Re: **Corazon Santo Subdivision/Homewise Inc.; Construction Stormwater; SIC 1522; NPDES Compliance Evaluation Inspection; NPDES # NMR1000BN; November 16, 2017**

### NPDES Compliance Inspection Report

## NPDES Construction General Permit Inspection Report – State of New Mexico

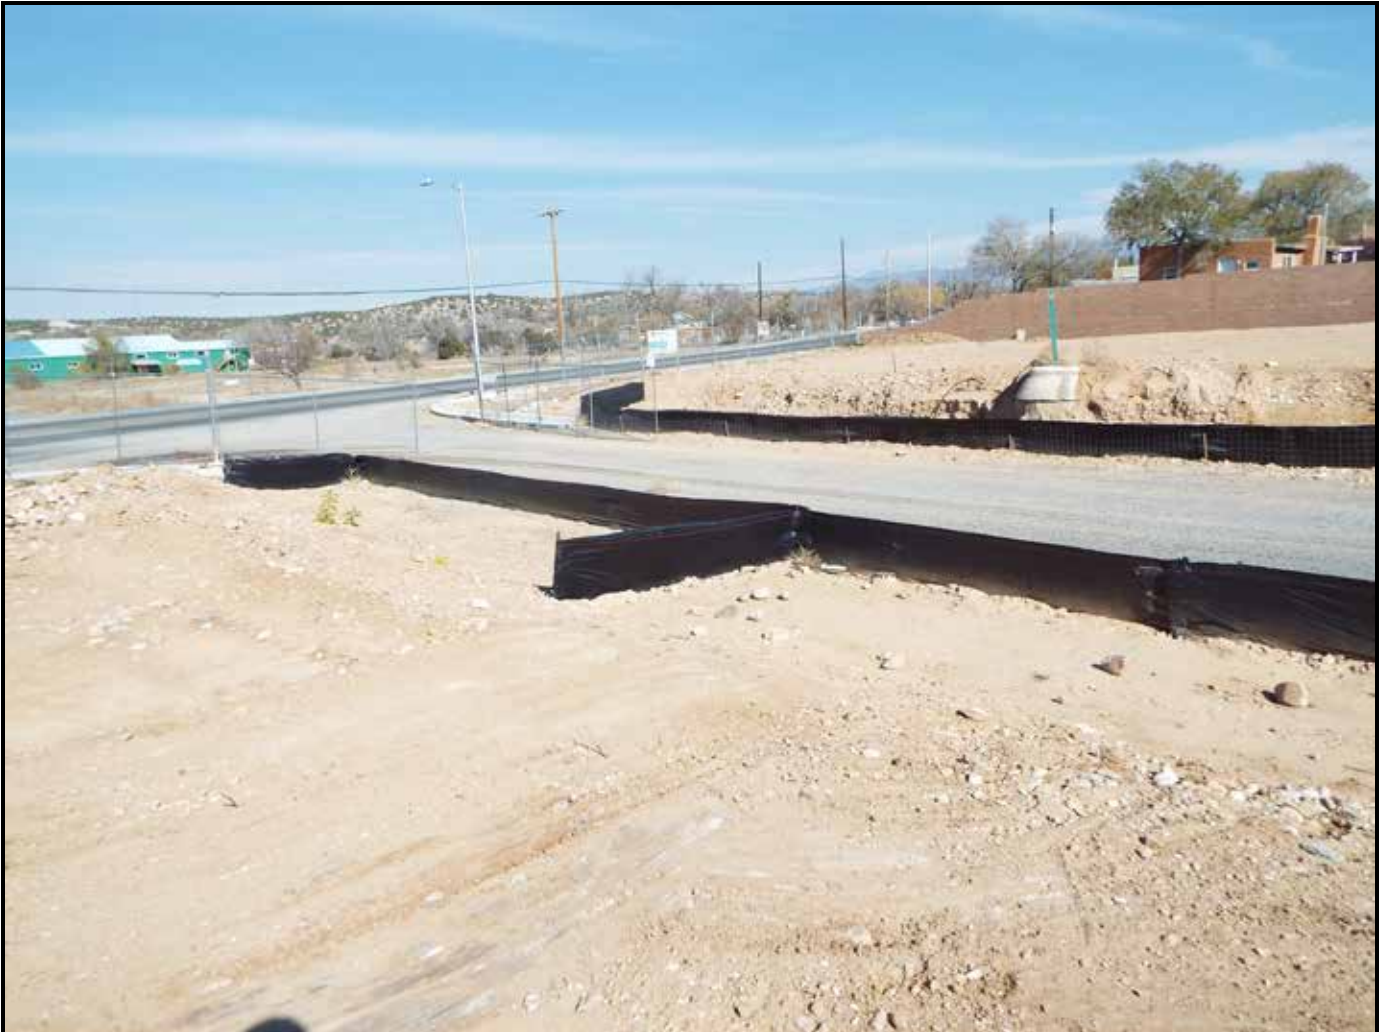
Photo # 1

Photographer: Daniel Valenta	Date: 11/16/2017	Time: 1150 hours
City/County: Santa Fe/Santa Fe County		
Location: 2736-2738 Agua Fria Street, Santa Fe, New Mexico		
Subject: Entrance to site.

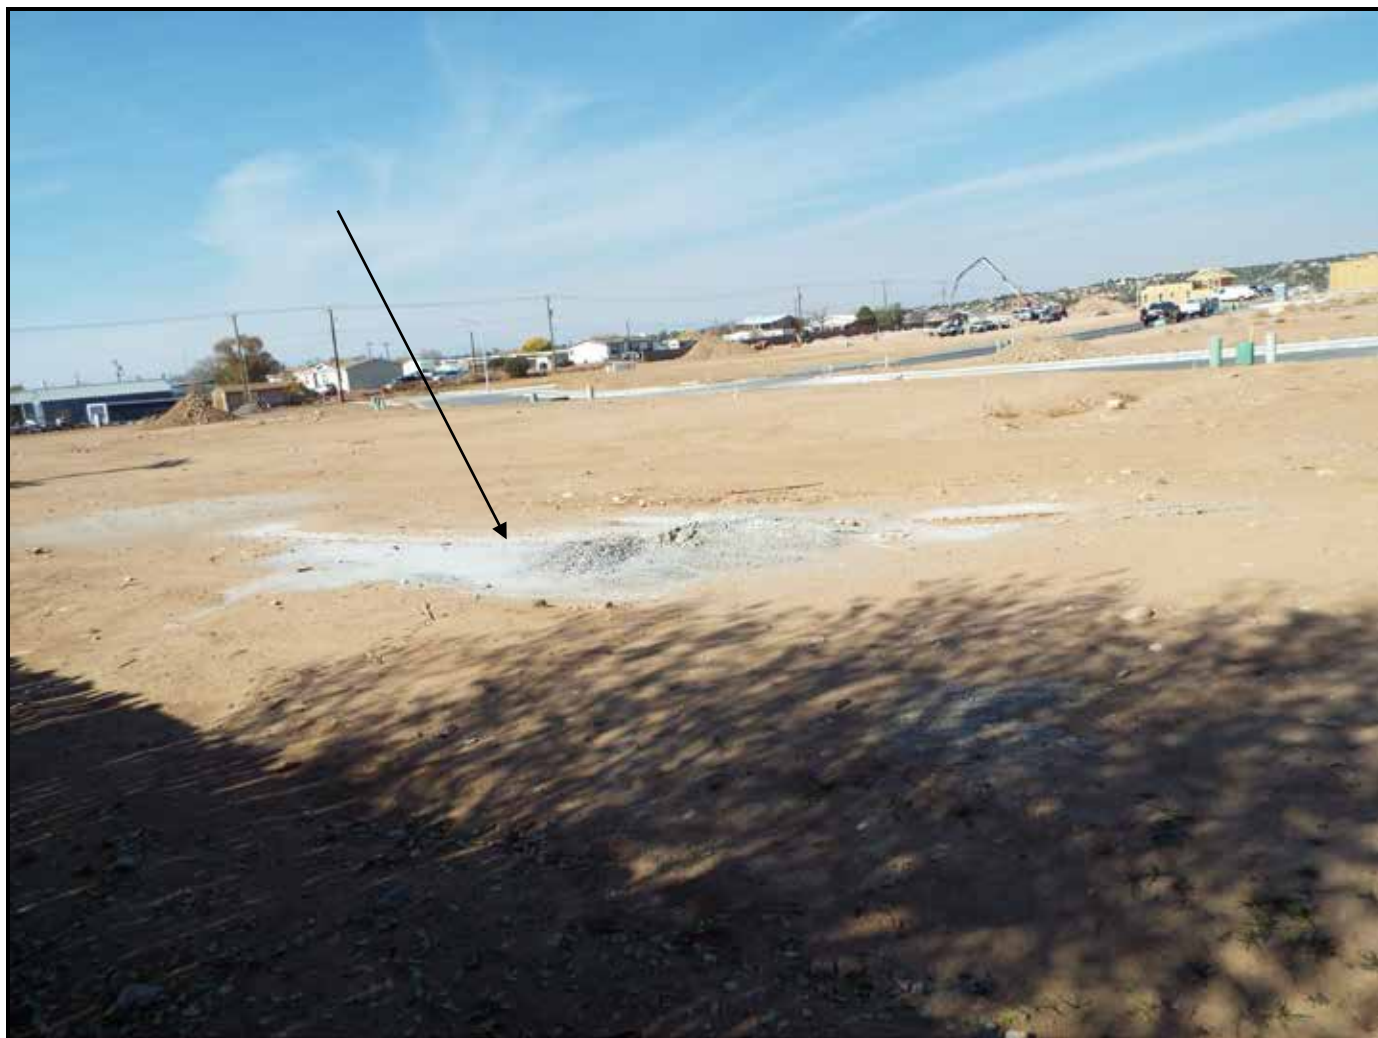
Photo # 2

- A hole was dug on the north side of the side to contain concrete washout. The pit was not lined as required.
- Concrete washout was found on the ground on the south side of the side, a washout container was present at the site.

Photographer: Daniel Valenta	Date: 11/16/2017	Time: 1142 hours
City/County: Santa Fe/Santa Fe County		
Location: 2736-2738 Agua Fria Street, Santa Fe, New Mexico		
Subject: Corazon Santo Subdivision construction project. Concrete wash out spilled on south side of site.

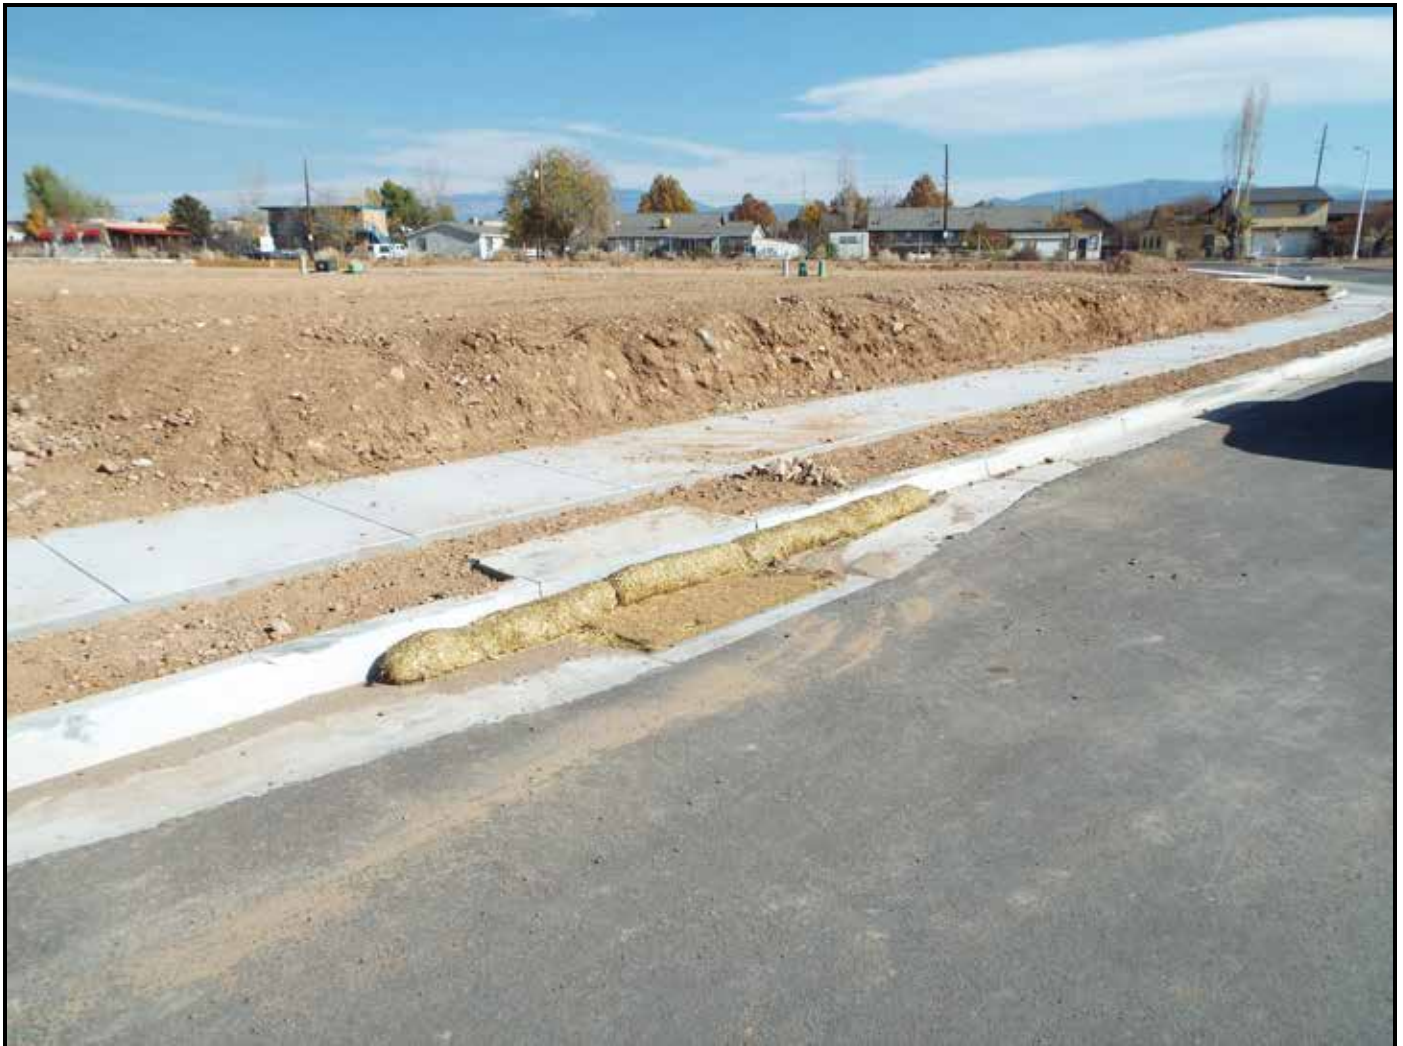
Photo # 3

Photographer: Daniel Valenta	Date: 11/16/2017	Time: 1143 hours
City/County: Santa Fe/Santa Fe County		
Location: 2736-2738 Agua Fria Street, Santa Fe, New Mexico		
Subject: Storm drains have BMPs in place.

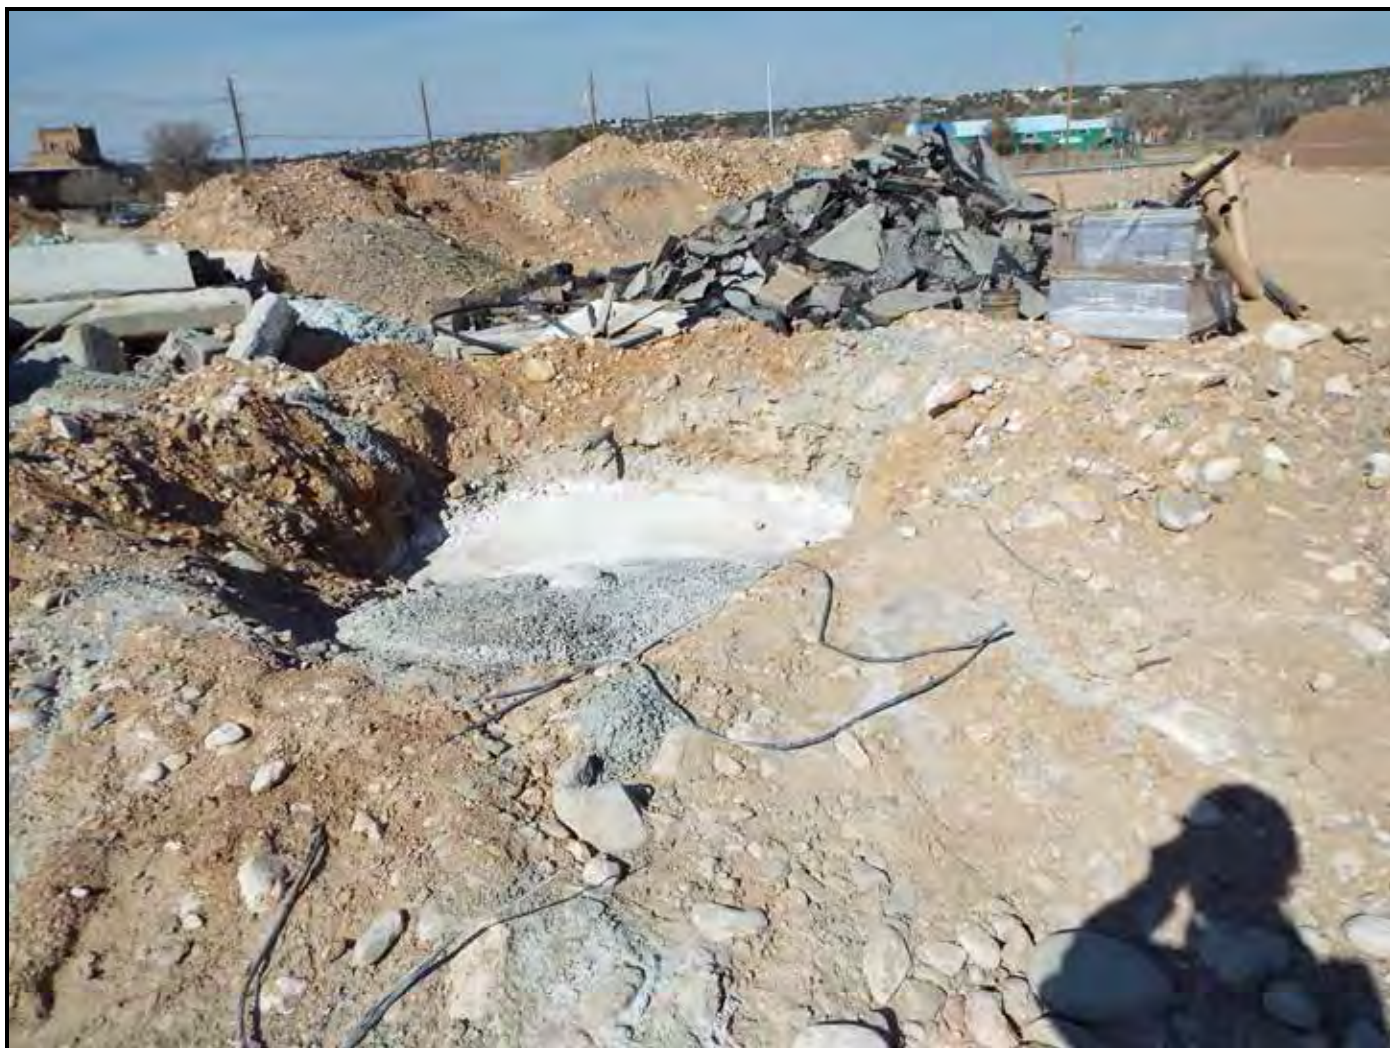
Photo # 4

Photographer: Daniel Valenta	Date: 11/16/2017	Time: 1148 hours
City/County: Santa Fe/Santa Fe County		
Location: 2736-2738 Agua Fria Street, Santa Fe, New Mexico		
Subject: Unlined concrete waste pit on north side of the property.

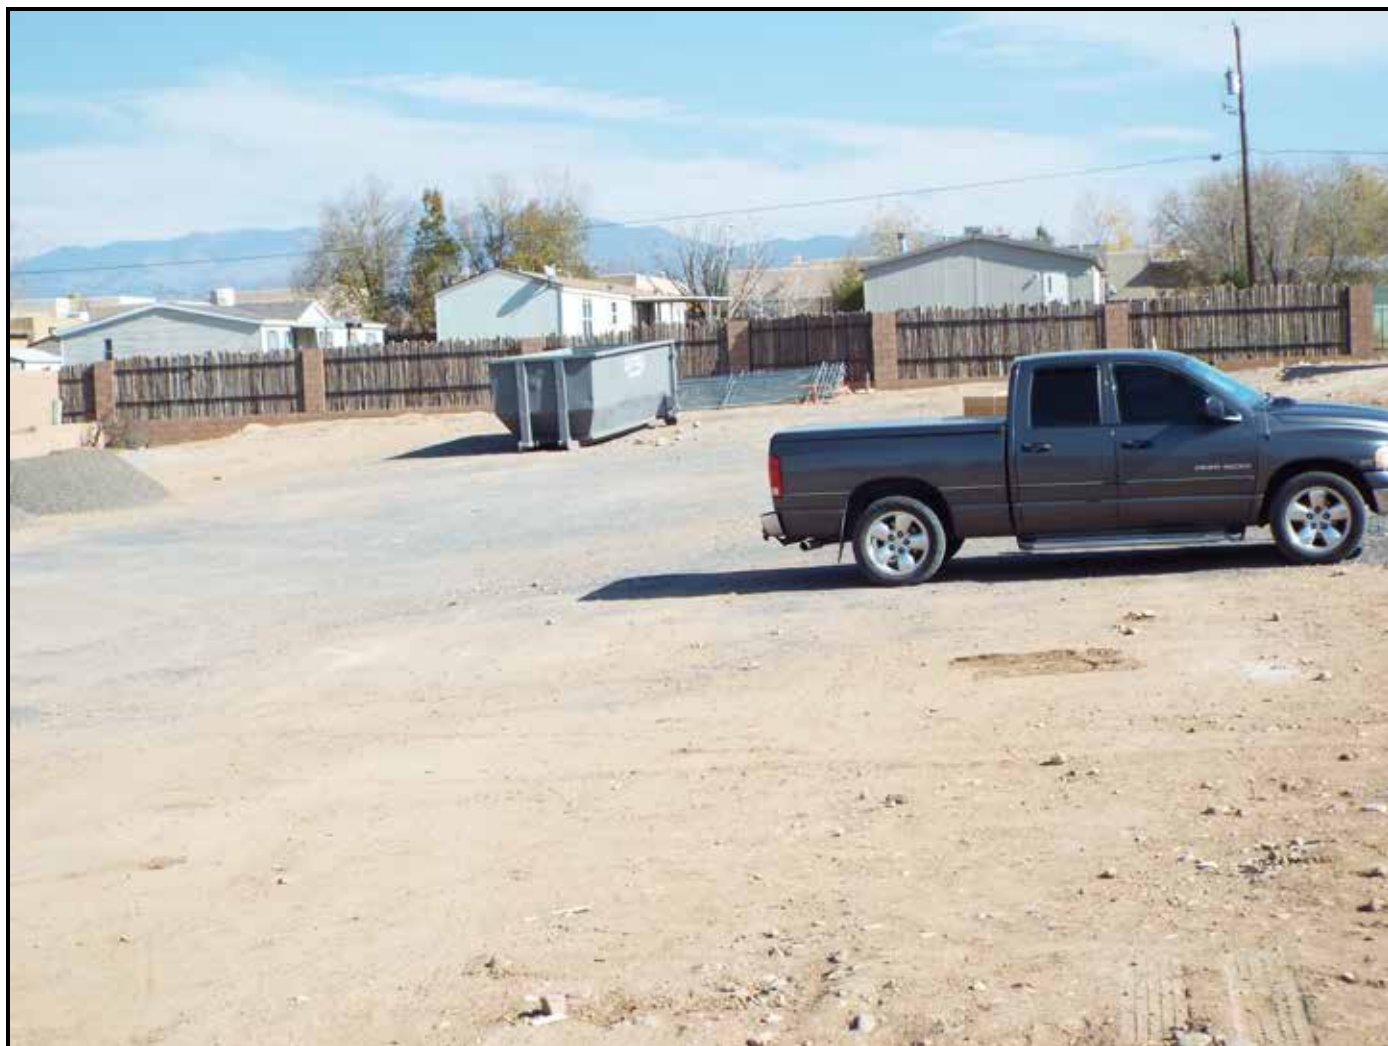
Photo # 5

- On site waste containers did not have lids or covers.

Photographer: Daniel Valenta	Date: 11/16/2017	Time: 1147 hours
City/County: Santa Fe/Santa Fe County		
Location: 2736-2738 Agua Fria Street, Santa Fe, New Mexico		
Subject: Waste container has no lid and is not covered.
